## **2012 Operations, Maintenance, and Monitoring Report**

### **FRESHWATER INTRODUCTION SOUTH OF HIGHWAY 82**

State Project Number ME-16  
Priority Project List 9

June 2012  
Calcasieu Parish

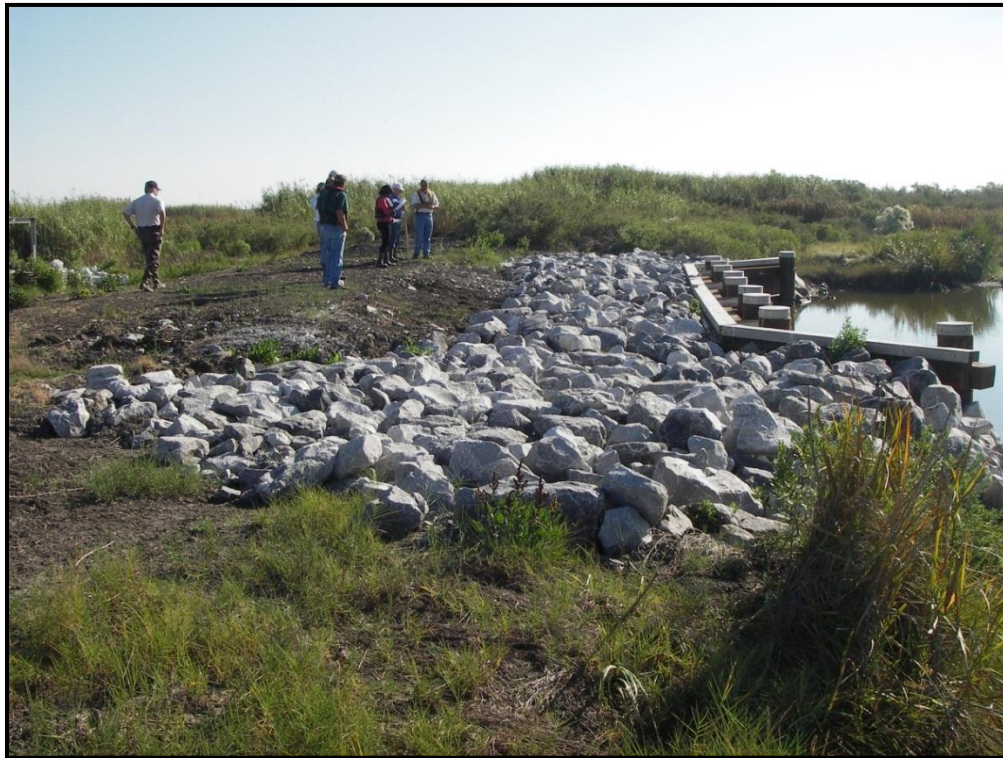
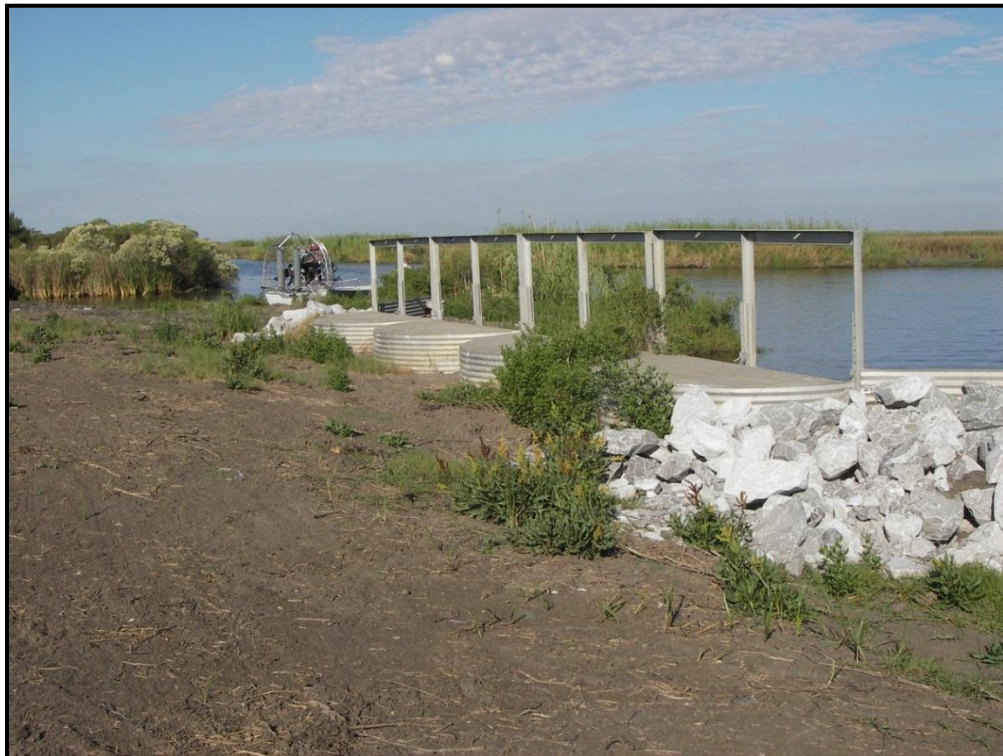
The structure is in good condition. Leaks at interface of pipe and headwall discovered during the recent maintenance project have been repaired by the contractor. Rock revetment looks good. Contractor needs to provide lifting chains for lifting of flapgates. (Photos: Appendix A, Photos 1 & 2)

**Photo No. 1,** New Cop-Cop Structure, rock placement on outlet side of structure.

**Photo No. 2,** New Cop-Cop Structure, inlet side of structure.

Item	Condition	Physical Damage	Corrosion	Photo #	Observations and Remarks
Flapgates	Good				Contractor needs to provide lifting chains for opening flapgates.
Steel Grating	Good			2	
Stop Logs	Good				
Hardware	Good				
Timber Piles	Good			1	
Timber Walkway					
Timber Wales	Good				
Galv. Pile Caps	Good				
Culverts	Good				Leaks discovered by the contractor at the interface of the culvert and headwall have been repaired by the contractor.
Signage / Supports	N/A				
Staff Gages					
Rip Rap (fill)	Good			1 & 2	
Earthen Embankment	Good				
What are the conditions of the existing levees?					
Are there any noticeable breaches?					
Settlement of rock plugs and rock weirs?					
Position of stoplogs at the time of the inspection?					
Are there any signs of vandalism?

- Lifting chains should be provided on the flapgates at the New Dyson, New Cop Cop, and Structure No. 10.
- Rock rip rap should be filled in closer to the structure at Structure No. 10.
- Concrete on the Little Constance Structure which was damaged by the rock placement during the maintenance event needs repair.

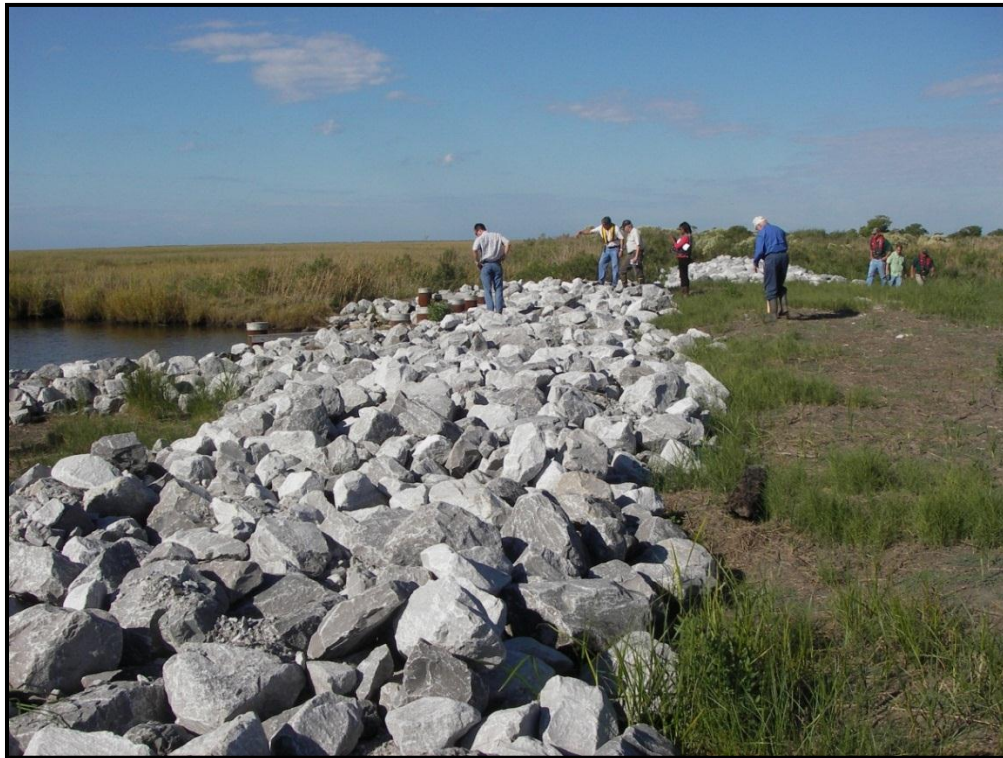
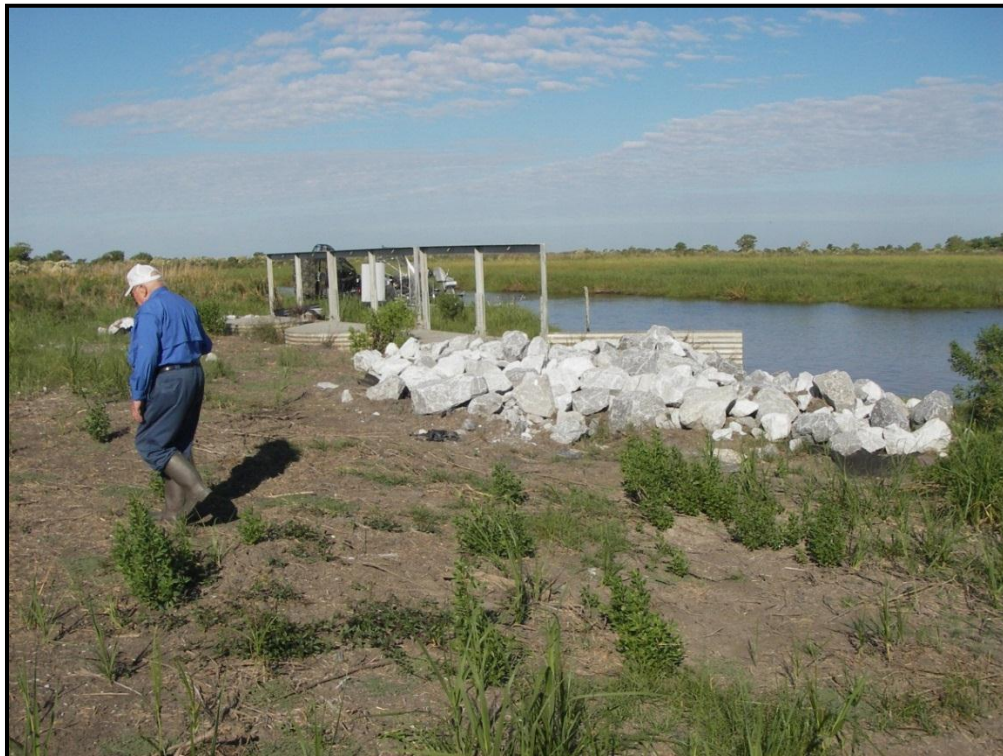
Overall this structure is also in good condition. Rock revetment looks good. (Photos: Appendix A, Photo 3 & 4)

**Photo No. 3,** Structure No. 12, rock placement on outlet side of structure.

**Photo No. 4,** Structure No. 12, rock placement on inlet side of structure.

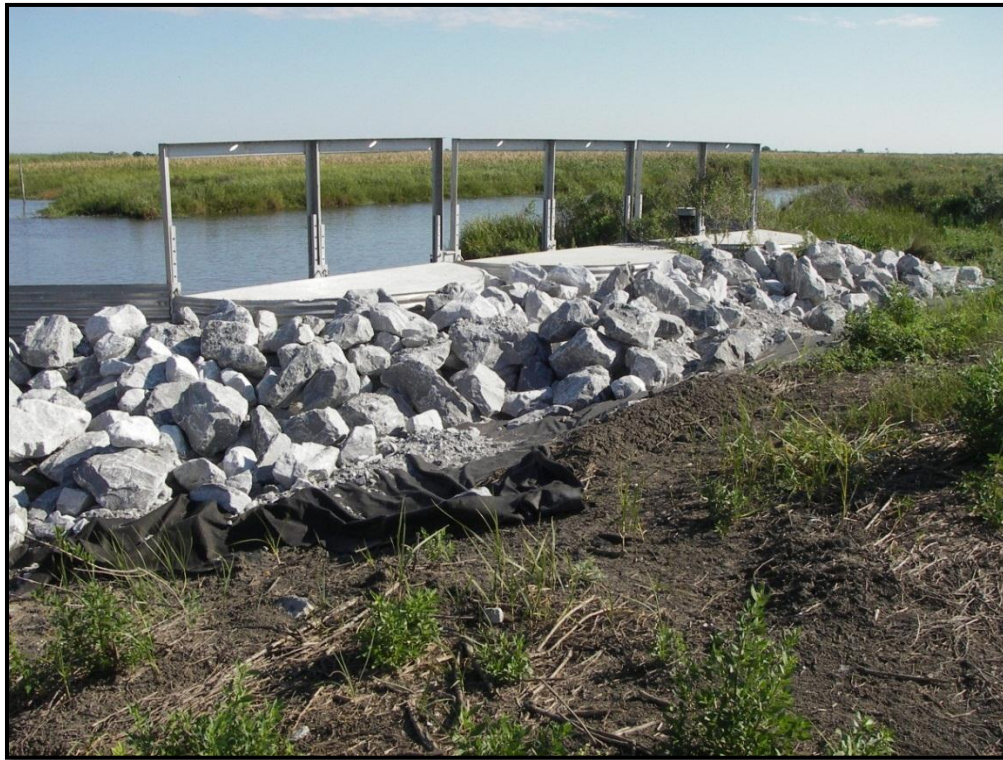
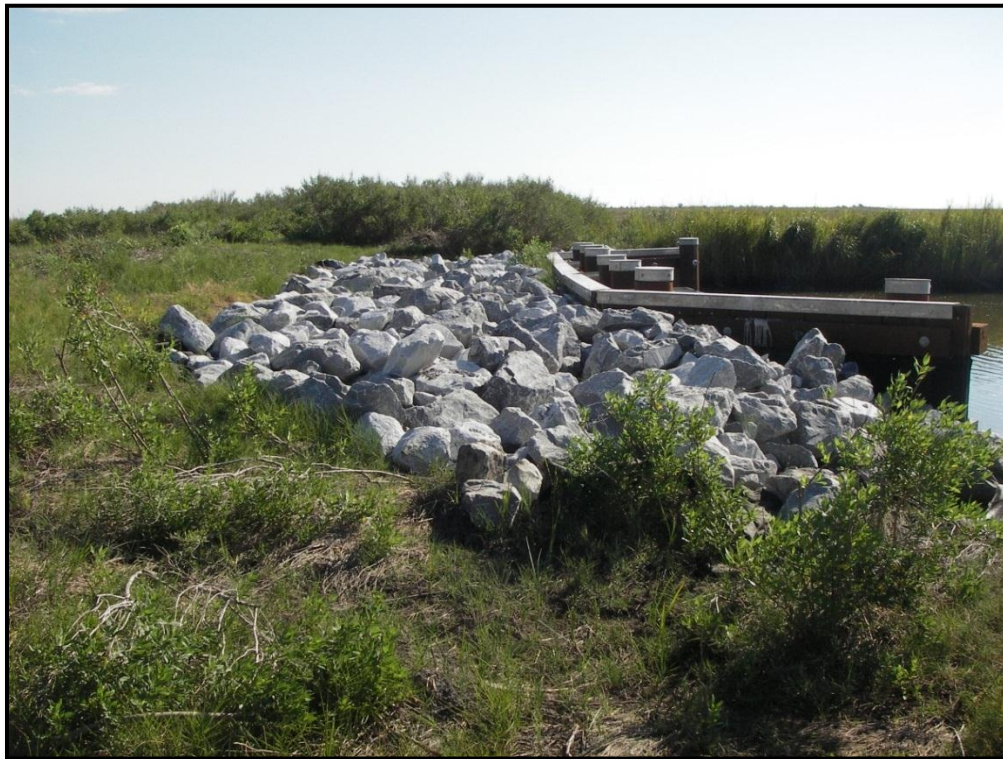
Overall this structure is in good condition. Rock revetment looks good. Contractor needs to move some rock closer to the structure and provide lifting chains for lifting of flapgates. (Photos: Appendix A, Photo 5 & 6)

**Photo No. 5,** Structure No. 10, rock placement on inlet side of structure.

**Photo No. 6,** Structure No. 10, rock placement on outlet side of structure.

Item	Condition	Physical Damage	Corrosion	Photo #	Observations and Remarks
Flapgates	Good				Contractor needs to provide lifting chains for opening the flapgates.
Steel Grating	Good			5	
Stop Logs	Good				
Hardware	Good				
Timber Piles	Good			6	
Timber Walkway					
Timber Wales	Good				
Galv. Pile Caps	Good			6	
Cables	N/A				
Signage / Supports	N/A				
Staff Gages					
Rip Rap (fill)	Good			5 & 6	Contractor needs to move some rock closer to the structure.
Earthen Embankment	Good			5 & 6	
What are the conditions of the existing levees?					
Are there any noticeable breaches?					
Settlement of rock plugs and rock weirs?					
Position of stoplogs at the time of the inspection?					
Are there any signs of vandalism?

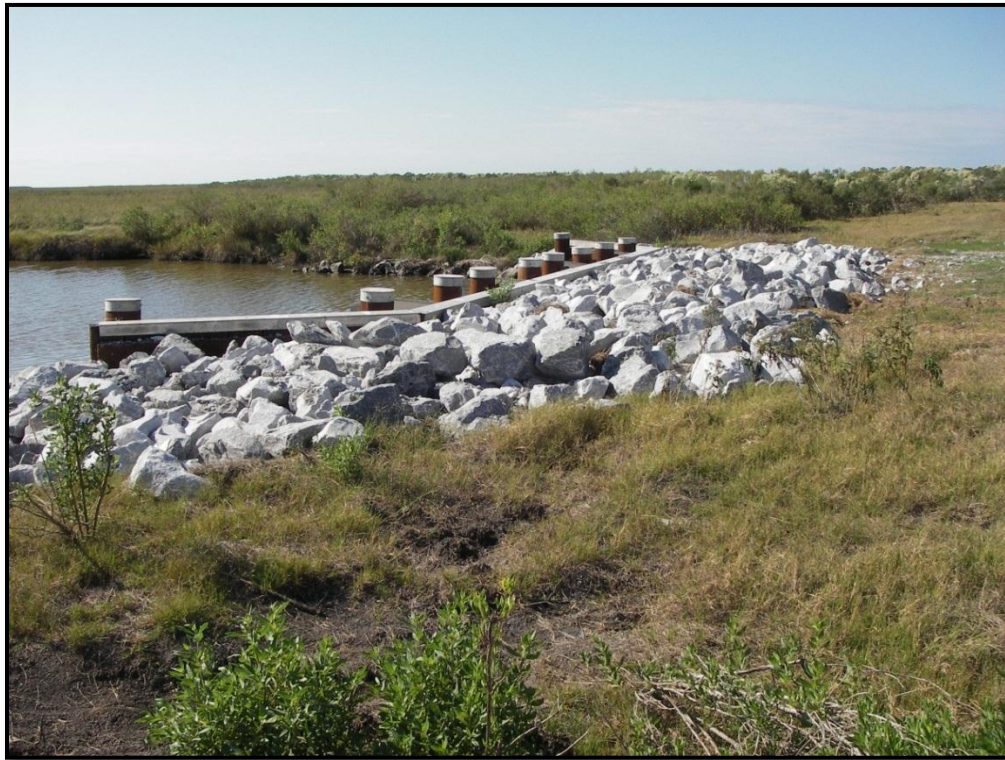
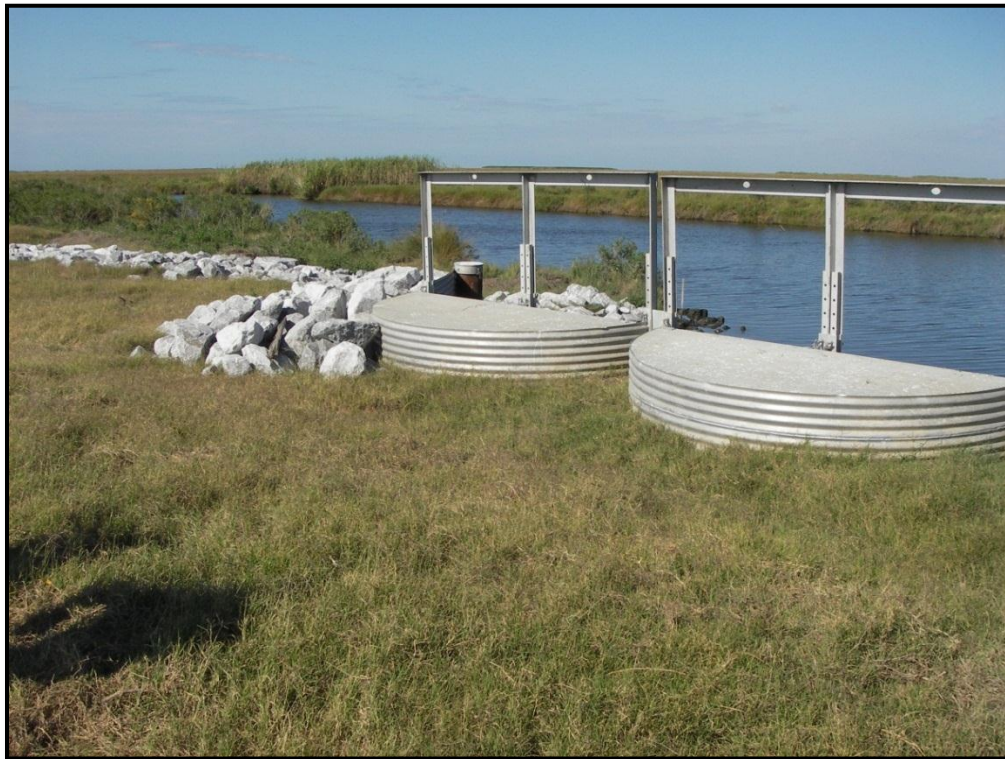
Overall this structure is in good condition. Rock revetment looks good. Contractor needs to provide lifting chains for lifting of flapgates. (Photos: Appendix A, Photo 7 & 8)

**Photo No. 7,** New Dyson Structure, rock placement on outlet side.

**Photo No. 8,** New Dyson Structure, rock placement on inlet side.

Item	Condition	Physical Damage	Corrosion	Photo #	Observations and Remarks
Flapgates	Good				Contractor needs to provide lifting chains for opening flapgates.
Steel Grating	Good				
Stop Logs	Good				
Hardware	Good				
Timber Piles	Good				
Timber Walkway					
Timber Wales	Good				
Galv. Pile Caps	Good				
Culverts	Good				Leaks discovered by the contractor at the interface between the culverts and headwall have been repaired.
Signage / Supports	N/A				
Staff Gages					
Rip Rap (fill)	Good			7 & 8	
Earthen Embankment	Good			7 & 8	
What are the conditions of the existing levees?					
Are there any noticeable breaches?					
Settlement of rock plugs and rock weirs?					
Position of stoplogs at the time of the inspection?					
Are there any signs of vandalism?

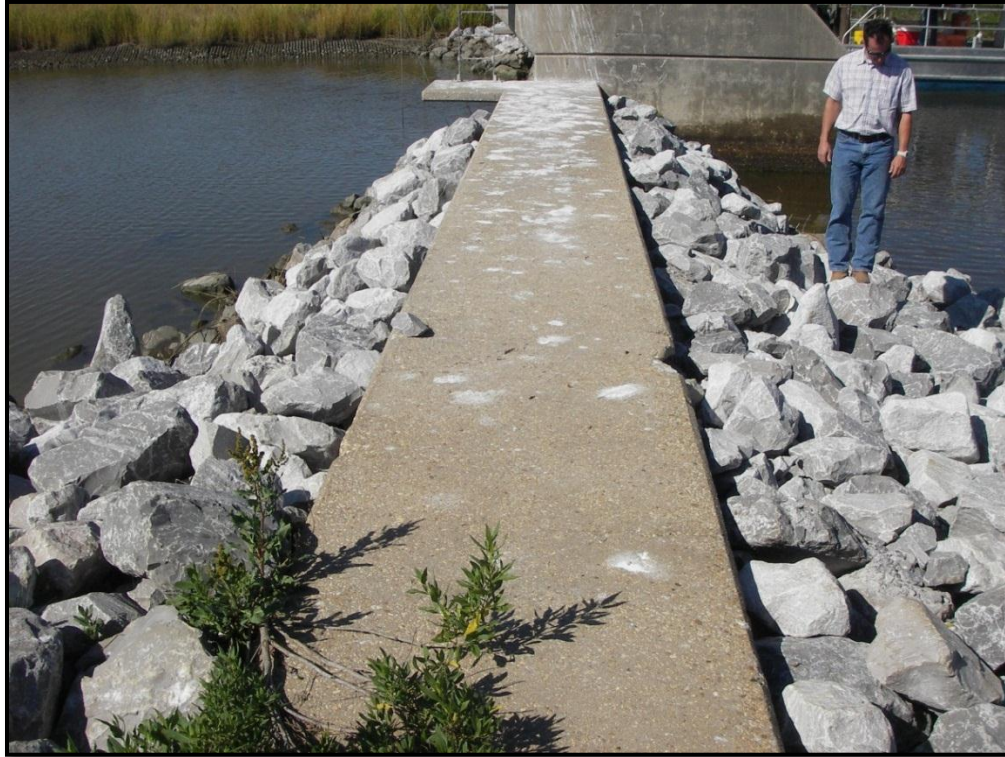
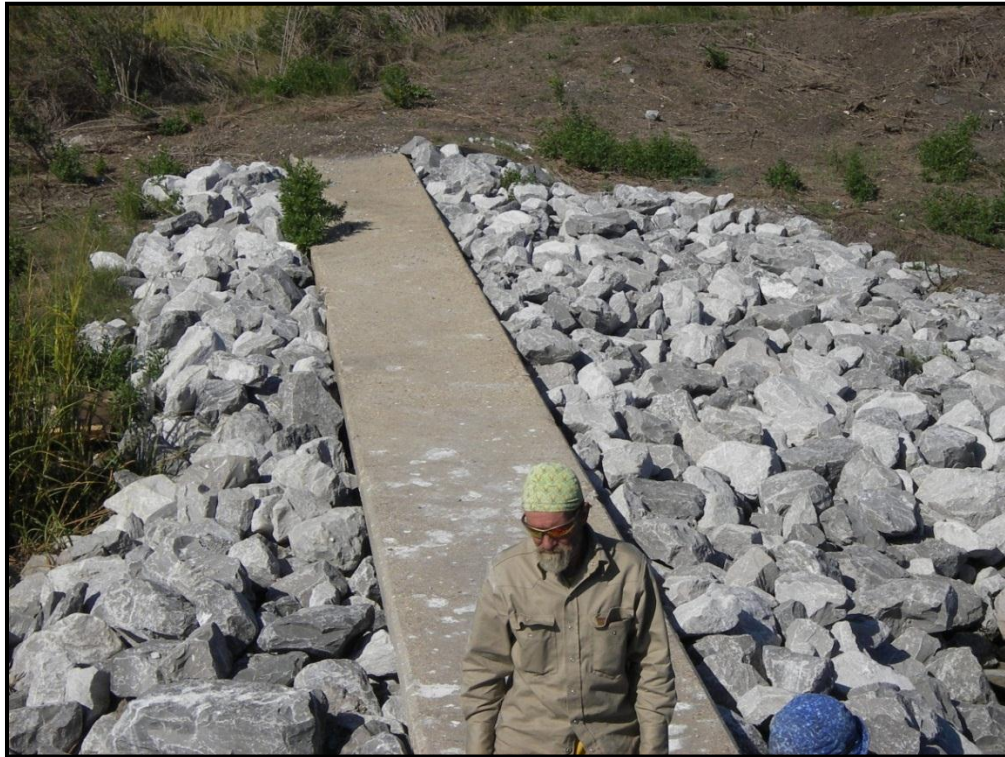
Overall this structure is in good condition. Rock revetment looks good. Contractor needs to repair section of broken concrete on structure, which occurred by rock hitting structure during maintenance event. (Photos: Appendix A, Photo 9 & 10)

**Photo No. 9,** Little Constance Structure, rock placement on east side of structure.

**Photo No. 10,** Little Constance Structure, rock placement on west side of structure.

Item	Condition	Physical Damage	Corrosion	Photo #	Observations and Remarks
Concrete Control Structure	Good				Contractor needs to repair section of broken concrete on structure which occurred during the rock maintenance event.
Flap Gates	Good				
Stop Logs	Good				
Hardware	Good				
Timber Piles	N/A				
Timber Walkway	N/A				
Timber Wales	N/A				
Galv. Pile Caps	N/A				
Cables	Good				
Signage / Supports	N/A				
Staff Gages	N/A				
Rip Rap (fill)	Good			9 & 10	Looks Good.
Earthen Embankment	N/A				
What are the conditions of the existing levees? Are there any noticeable breaches? Settlement of rock plugs and rock weirs? Position of stoplogs at the time of the inspection? Are there any signs of vandalism?

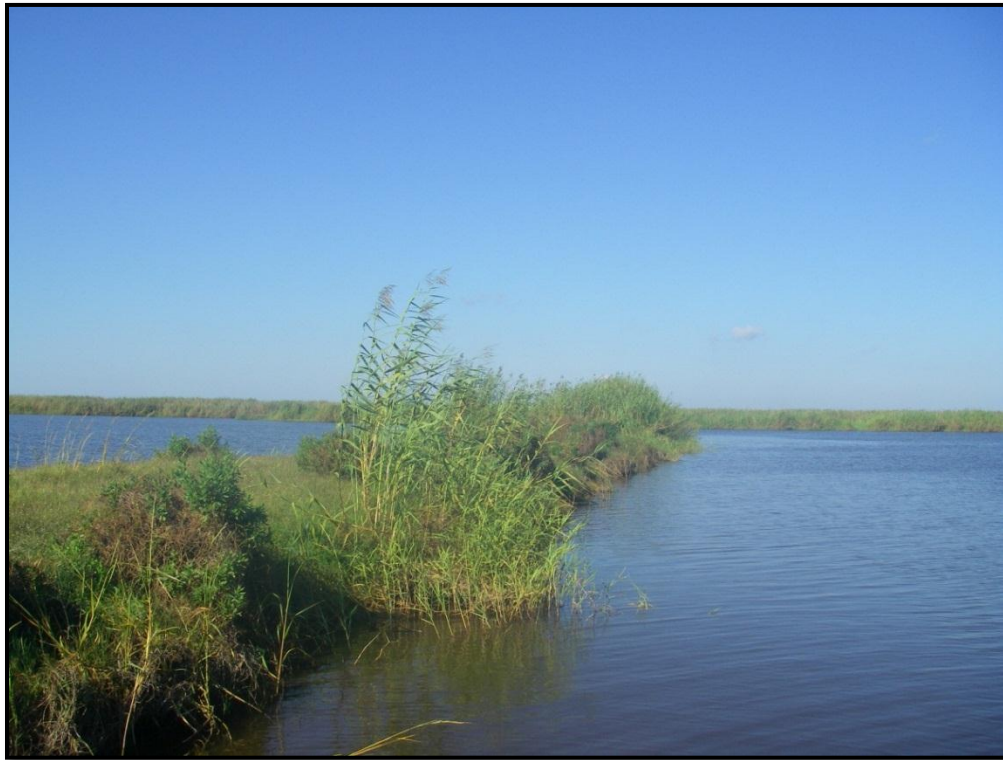
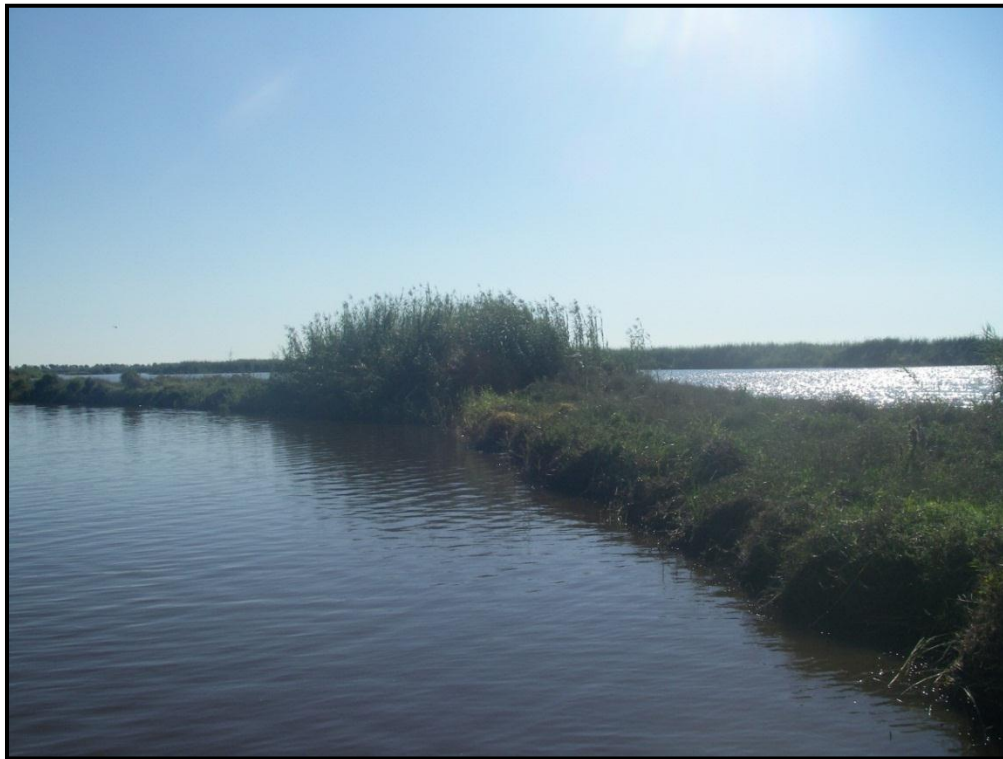
**Photo No. 11, Earthen Terraces**

The terrace field is in very good condition. The vegetation is healthy and there appears to be little erosion. (Photos: Appendix A, Photo 11 & 12)
